Hawksmoor's tunnel vault ceiling prior to conservation

ALL SOUL'S COLLEGE, OXFORD

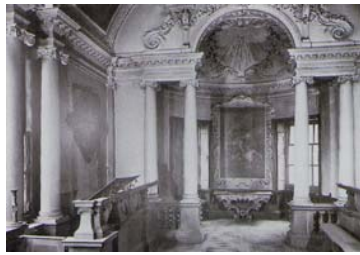
Paine's chapel, 1952
Note the dark area on the ceiling to the left of the photograph.

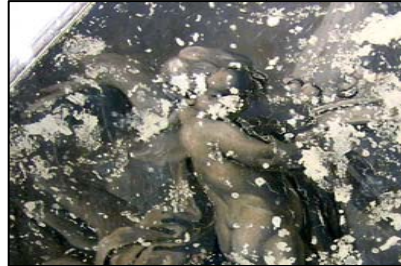
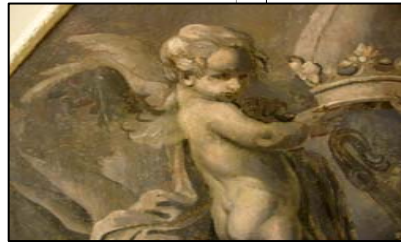
Clues hidden in the archives hinted at a far more spectacular past.

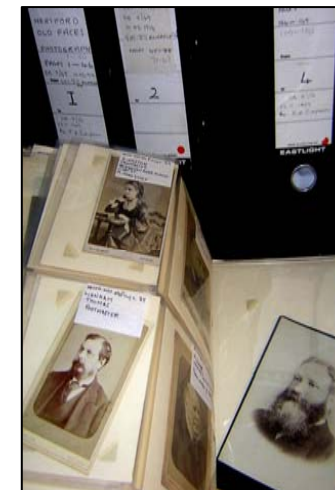
Hertford Museum houses a diverse range of artefacts

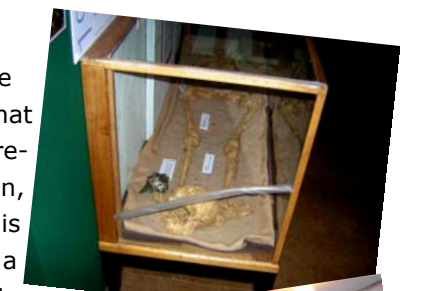
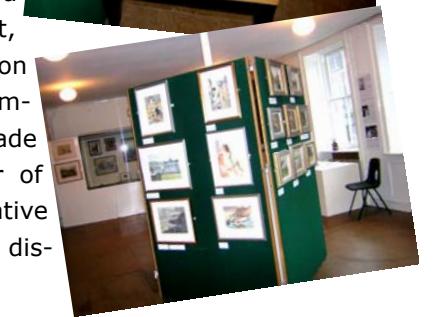
The scale of the work required to fulfil the trustee's mandate for Hertford Museum can now be more fully appreciated.
